**VOLUNTARY CLEANUP  
AND  
REDEVELOPMENT ACT APPLICATION  
FOR  
ARGENTINE TAILINGS SITE  
RICO, COLORADO**

Submitted to:  
**COLORADO DEPARTMENT OF  
PUBLIC HEALTH AND ENVIRONMENT**

Submitted by:  
**Atlantic Richfield Company  
Rico Development Corporation  
Rico Properties, L.L.C.  
Val Truelsen and Deanna Truelsen**

February 1996

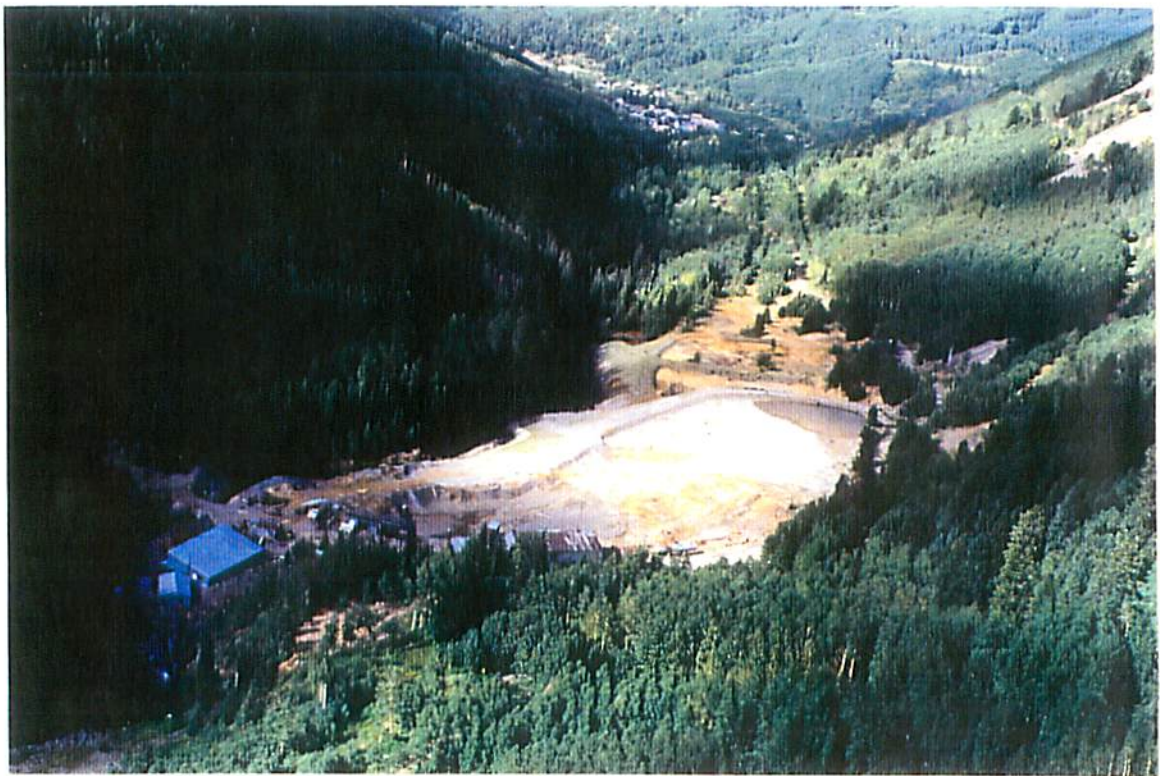
Figure 2-2b. Argentine Tailings (west) September, 1995
